**2005-CVB-R0160**

Determination of the fire resistance of an aluminium door construction, type FP-67, according to NEN-EN 1634-1: 2001 in conjunction with NEN 6069:2001

Project name Fire resistance door construction  
Project number 006.55714/01.01

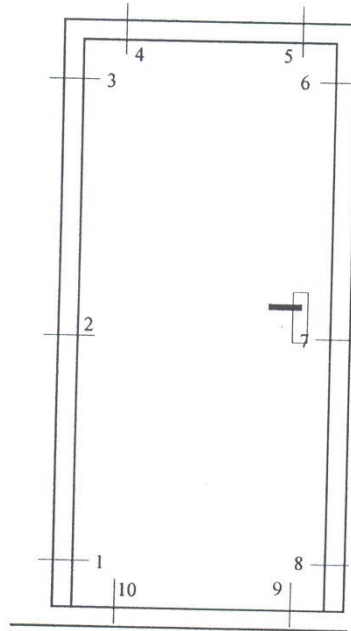
Figure 8.1 –Door joint widths measurement positions

Door gap measured at both side (exposed and non-exposed)  
No difference between.

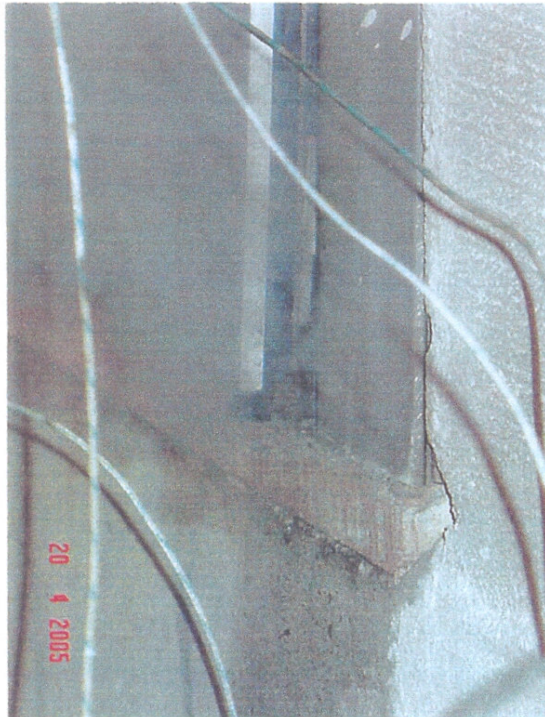
D2: Specimen after 15 minutes

7:00	The lower pane at the directly exposed side is falling down into the furnace.
15:00	Topmost point of the door on locking side bend a distance of 30 mm from the fire, lowest point 20 mm.

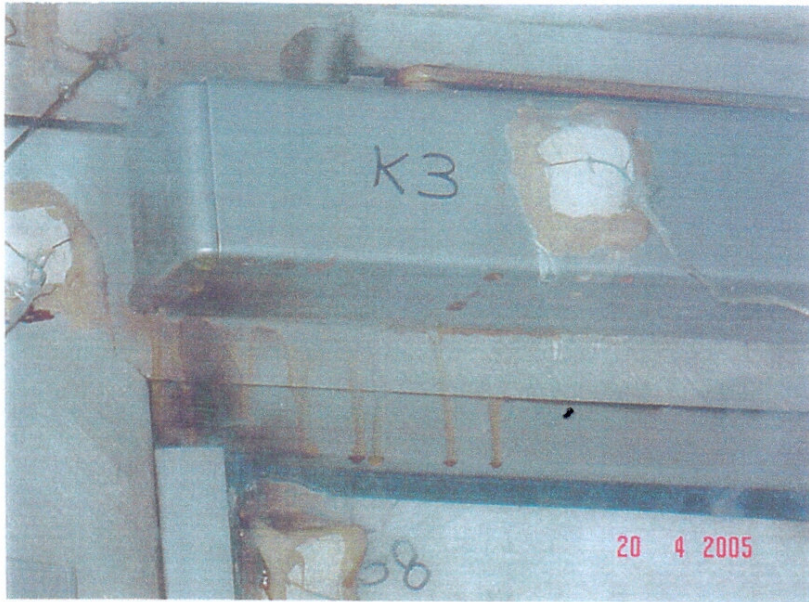
D3: Door-closing device after 50 minutes

41:30	Cap of the upper hinge is falling down.
45:00	Smoke escape over a distance of 300 mm between topmost horizontal glass profile and doorframe.
47:30	Oil is falling down out of the door-closing device.

66:00	Upper pane start to sag.
76:00	Oil leaking out of the door-closing device has been stopped.
90:00	Red glare is visible at the top of the upper pane.

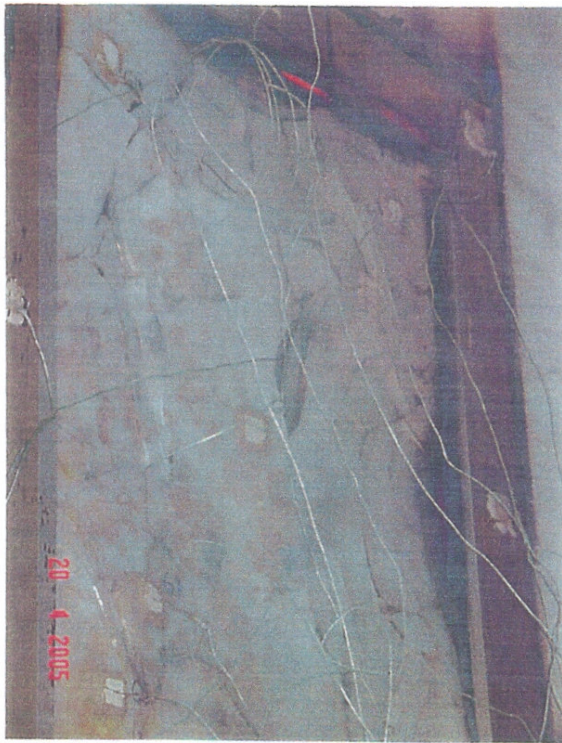
D4: Lower pane after 93 minutes

At the 62<sup>nd</sup> minute the 360°C temperature rise was reached at thermocouple K4. At the 96<sup>th</sup> minute flames were visible longer than 10 seconds: "*end of integrity criterion based on sealing*".

93:00	Flames are visible shorter than 2 sec at the top of the lower pane
96:00	Flames are longer visible than 10 sec at the top of the lower pane. <i>"End of integrity criterion based on sealing".</i>

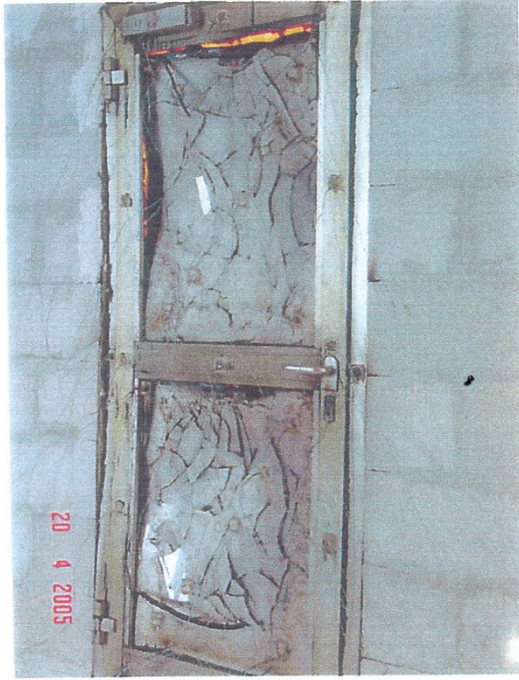
D5: Specimen after 97 minutes

97:00	End of measurements, recordings an heating
